Roca Urinal Odour Problems

This report documents an investigation into persistent odour issues associated with a Roca siphonic urinal installation. The initial focus on identifying and addressing odour sources expanded to uncover maintenance and operational factors contributing to the problem.

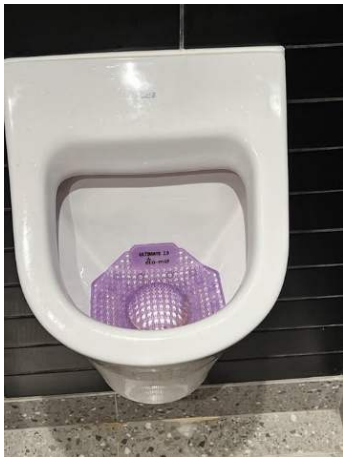
Urinal Mat Installation

- Displays a purple "Ultimate 2.0 Eco-Mat" incorrectly placed over the kee-seal waste trap in a Roca siphonic urinal.
- A urinal mat is not compliant with Roca's operational guidelines by disrupting the engineered water flow essential for siphonic flushing.
- The textured mat surface interferes with laminar water flow, preventing effective vacuum formation and efficient flushing.
- Accumulates debris, hair, and organic matter, exacerbating blockages and microbial growth.

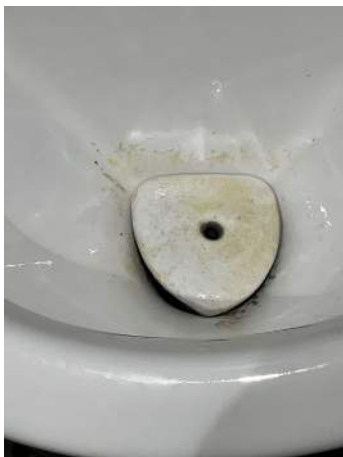
Struvite Accumulation in Trap Assembly

- Illustrates extensive white-to-yellow crystalline buildup (struvite—magnesium ammonium phosphate) within the kee-seal waste trap.
- This represents prolonged buildups, where calcium and protein in urine have reacted, forming mineral-like deposits.
- Critical siphon jet openings are clogged, obstructing the 4.2 m/s water velocity required for siphonic action.
- The brown discolouration signifies bacterial biofilm formation within the mineral matrix, increasing persistent odours and microbial hazards.

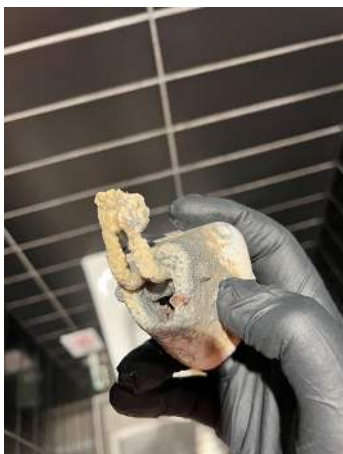
Trap Component Failure

- Catastrophic mineralisation fully covers the trap assembly, rendering internal pathways completely obstructed.
- Deposits appear densely layered, signalling long-term buildup and neglect beyond the scope of standard cleaning.

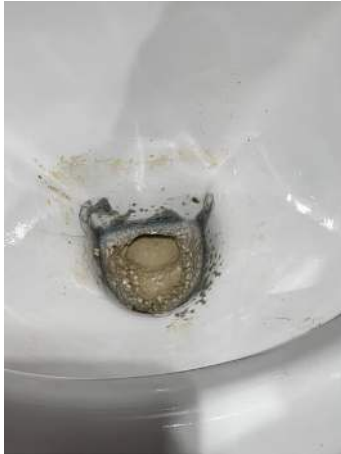
Compromised Bowl Seating Area

- Displays severe staining and mineral deposits around the trap interface following component removal.
- Clearly shows compromised sealing surfaces from sustained leakage caused by struvite buildup.
- Visible discolouration suggests chronic leakage, enabling sewer gases to migrate upward through the compromised seal, exacerbating odour problems.
- Indicates the loss of the 75 mm water seal depth necessary for odour and gas containment, significantly impacting hygienic conditions.

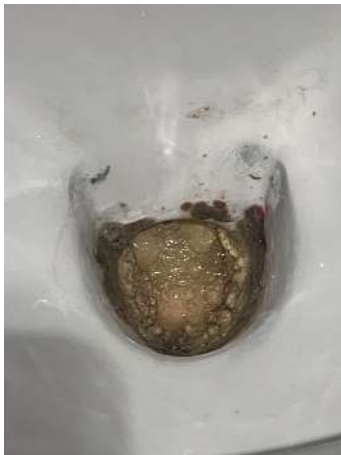
Advanced Struvite Accumulation in Bowl Interior

- Significant mineral buildup extends from the trap to the visible ceramic surfaces inside the bowl.
- Indicates prolonged accumulation allowing struvite to concentrate and crystallise.
- Specialised enzymatic products and prolonged treatment durations are mandatory to dissolve crystalline structures fully.

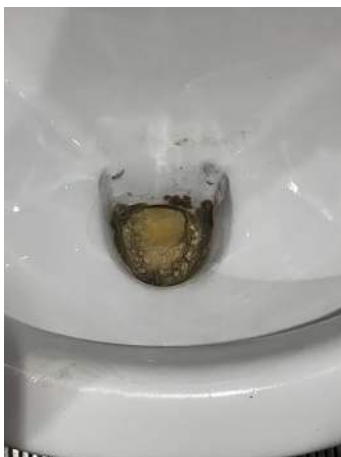
Persistent Mineralisation Despite Initial Treatment

- Shows the urinal bowl after initial cleaning attempts, indicating the continued presence of resistant struvite deposits.
- Highlights the inadequacy of standard cleaning agents and methods, reinforcing the necessity for professional-grade descaling solutions.
- Suggests the requirement for multiple intensive chemical treatments, potentially involving prolonged contact times (6-12 hours) for effective struvite removal.

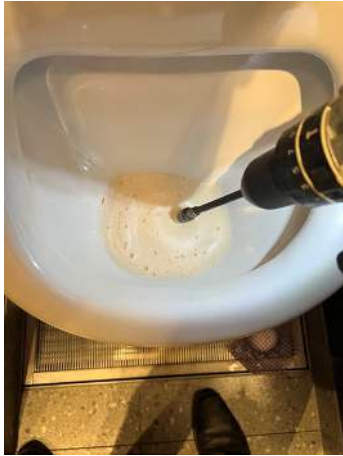
Professional Descaling Application in Progress

- Depicts active remediation with specialised foam-based enzymatic cleaner visibly applied, ensuring prolonged contact and vertical surface adherence.
- A power drill suggests mechanical agitation for breaking down hardened deposits, highlighting severity and neglect.
- Demonstrates a dual approach (chemical and mechanical) essential for successfully treating highly mineralised ceramic surfaces.

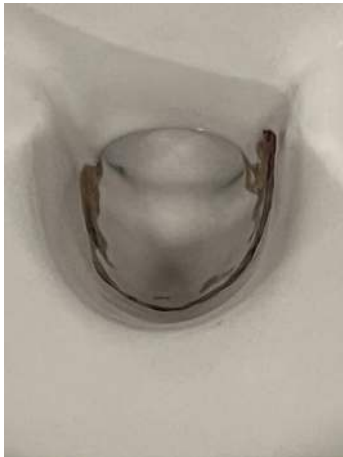
Successful System Restoration

- It clearly shows the complete restoration of urinal functionality with clean ceramic surfaces and properly seated trap components.
- Confirms restoring a correct 75 mm water seal depth, ensuring effective odour control.
- Indicates that extensive component replacements and thorough professional cleaning protocols have successfully restored operational integrity and hygiene.

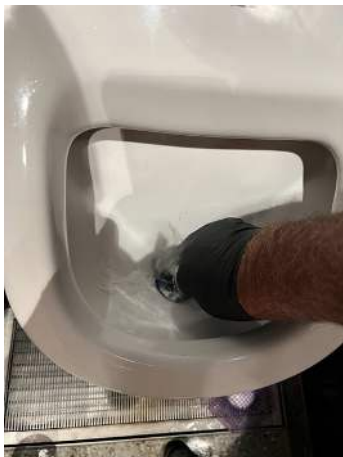
Precision Cleaning of Critical Components

- Highlights meticulous manual cleaning of internal urinal surfaces utilising specialised enzymatic cleaning foam.
- It ensures the complete removal of residual struvite and biofilm from complex, hard-to-access flow pathways, which is essential to prevent immediate recurrence.
- Demonstrates a thorough and precise approach critical for achieving reliable long-term functionality and maintaining siphonic efficiency.

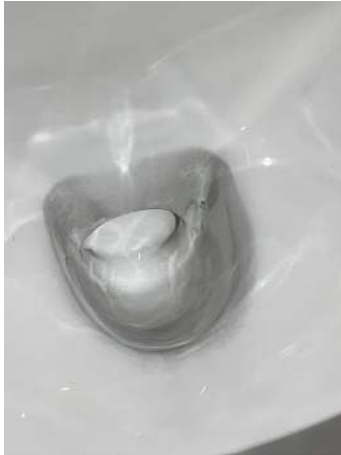
Component Treatment and Preparation

- Reveals an internal urinal fitting undergoing an intensive cleaning regimen, with visibly applied chemical agents designed to penetrate deeply into hardened mineral deposits.
- Highlights a staged cleaning process involving initial enzymatic applications, mechanical scrubbing, secondary descaling, and final sanitisation.
- Suggests prolonged neglect and emphasises the severity of contamination, mandating rigorous and systematic treatment procedures.

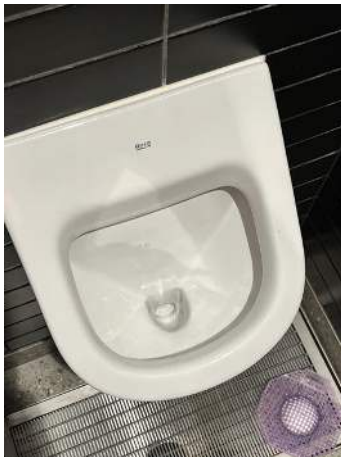
Complete System Restoration Success

- It depicts a fully rehabilitated urinal with pristine ceramic surfaces and an evident, functional water seal.
- It shows the purple urinal mat correctly positioned adjacent to but outside the urinal bowl, reflecting an implemented user education and accessory placement correction strategy.
- It confirms that professional-level restoration and preventative maintenance protocols have been effectively established, substantially reducing the likelihood of recurrence.

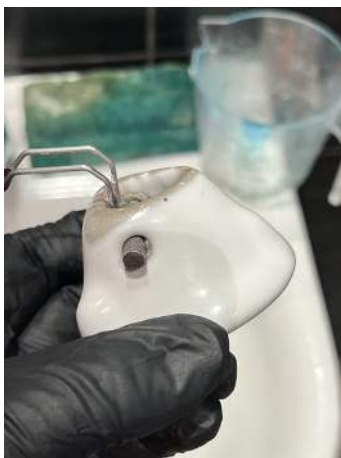
Individual Component Assessment and Handling

- Exhibits a technician in protective gloves closely examining a severely encrusted kee-seal waste trap component after removal.
- Demonstrates the magnitude and density of struvite mineralisation, confirming prolonged system neglect and ineffective previous maintenance.
- Suggests that simple in-situ treatment was impossible, necessitating detailed, intensive individual component cleaning or outright replacement.

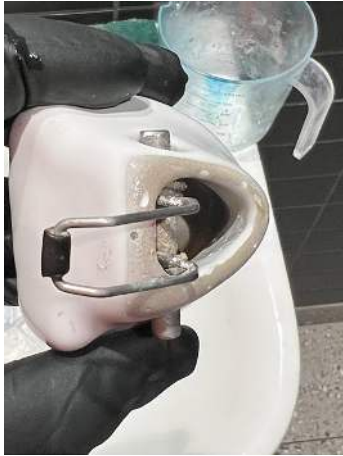
Intensive Chemical Treatment Application

- Captures active descaling treatments applied to heavily mineralised trap components, showing chemical reactions and mechanical agitation.
- Highlights meticulous application of professional-grade enzymatic solutions designed explicitly for dissolving dense, crystalline deposits over extended durations.
- Reinforces the difficulty in restoring severely mineralised components, stressing careful chemical selection and application protocols.

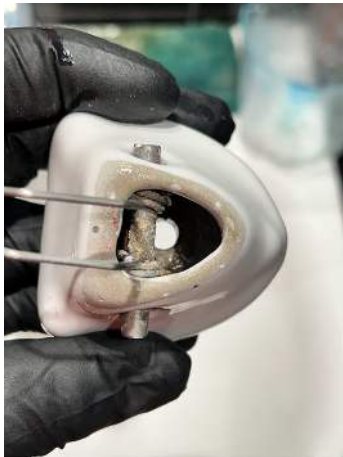
Final Component Cleaning Verification

- Presents continued rigorous treatment of heavily mineralised components from various angles, verifying extensive mineralisation persistence even during active cleaning.
- Suggests that despite intensive restoration efforts, some discolouration or damage may remain permanent, emphasising the cost-benefit of early intervention versus extreme remediation.
- Validates the necessity of component replacements over exhaustive restoration when deposits reach severe mineralised conditions.
